CJC[®] Oil Filtration presents

CJC[®] Varnish Removal Unit

Solution for removal of dissolved and suspended soft contaminants from oil in
Gas & Steam Turbines

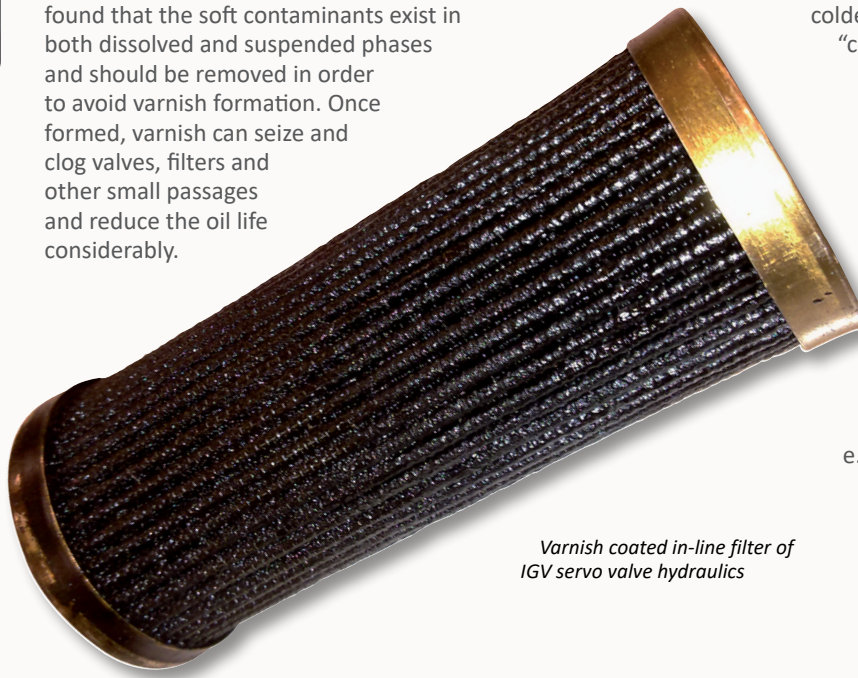
Varnish coated in-line filter of IGV servo valve hydraulics

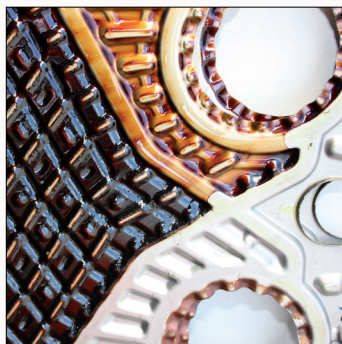
Varnish on plate heat exchanger

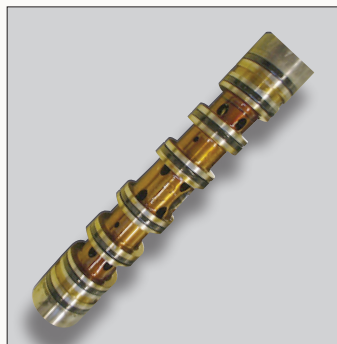
Varnish on valve spool

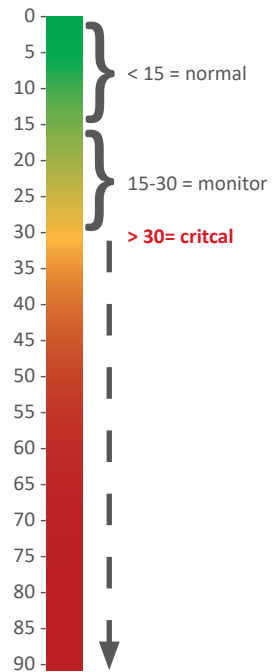
MPC Safe Level

A 95 MW Combined Cycle Power Plant in Spain. Two base loaded gas turbines each containing 6,500 L (1,700 gal) of Mobil DTE 832 oil. Varnish level measured with Membrane Patch Colorimetric was reduced from MPC 55 to MPC 15 within two weeks of operating the CJC® VRU. By using the CJC® VRU, a pending oil change and flushing were not necessary anymore, and turbine trips due to varnish were avoided!
